AccuCheck Home Inspection Services

ACCUCHECK HOME INSPECTION SERVICES

123 Sample Street, Demo City, ST 12345

5/20/2026 2:08PM

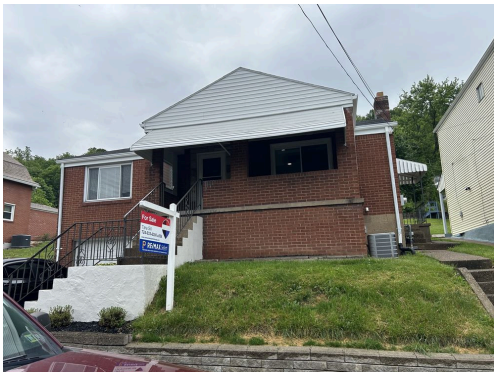
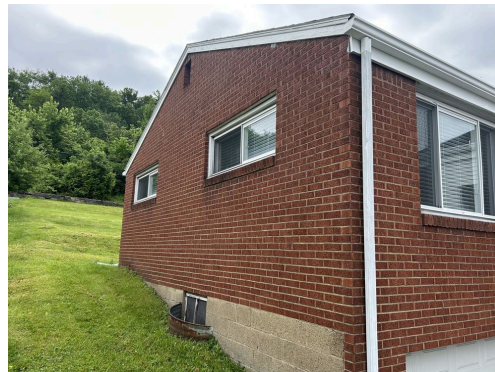
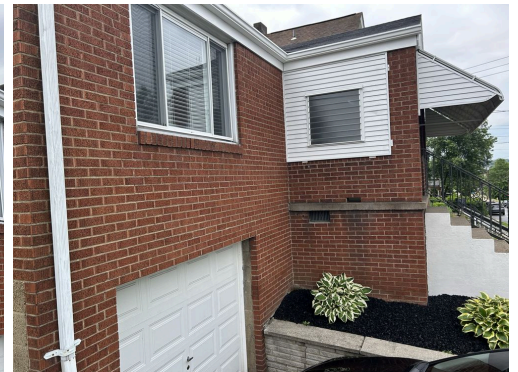
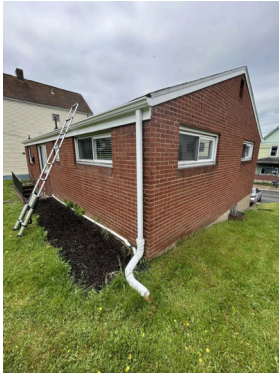
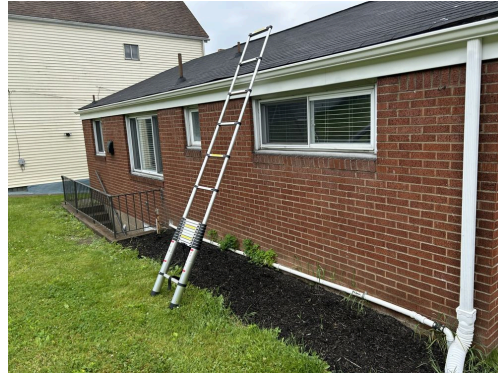
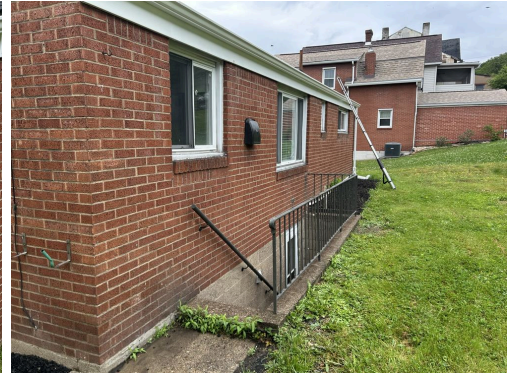
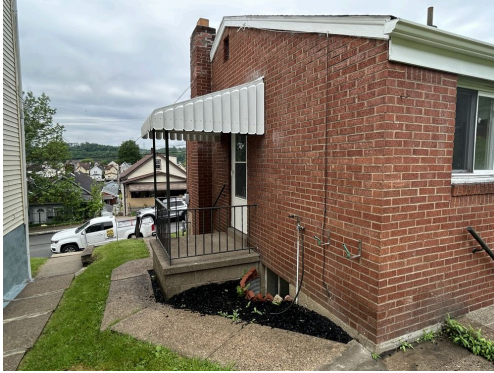
2.1.2 Exterior Inspection Completed

The exterior of the property was inspected. This included evaluation of visible exterior components, systems, and conditions as part of the comprehensive assessment.

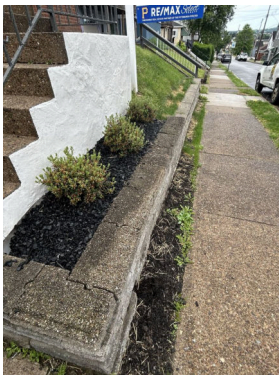
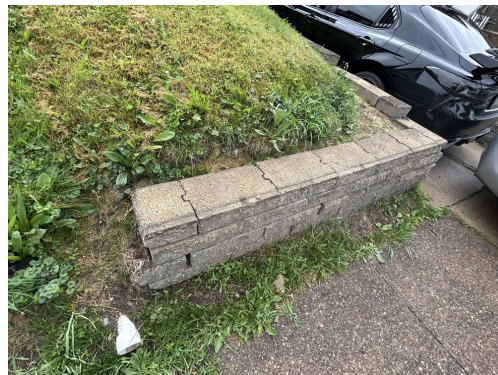
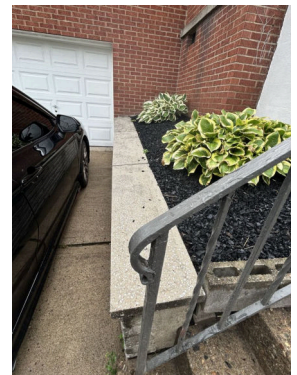
2.4.2 Negative Grading

Grading is sloping towards the home in some areas.

This could lead to water intrusion and foundation issues.

Recommend qualified landscaper or foundation contractor regrade so water flows away from home.

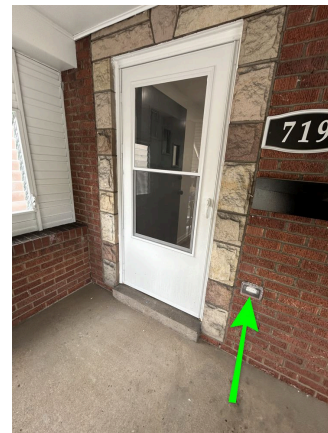
2.5.1 GFCI Inspected

I inspected & tested GFCI receptacle(s) on the exterior of the home.

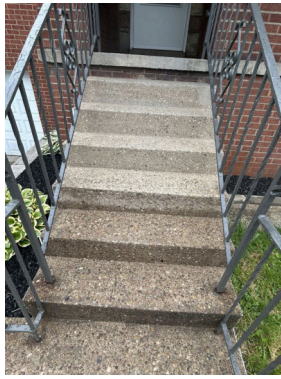
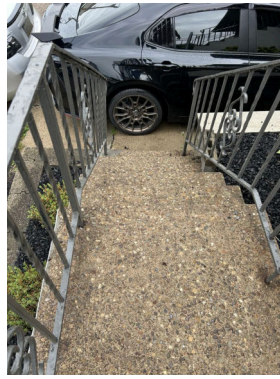
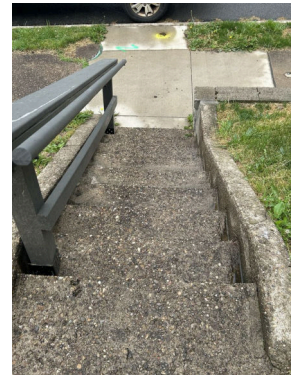
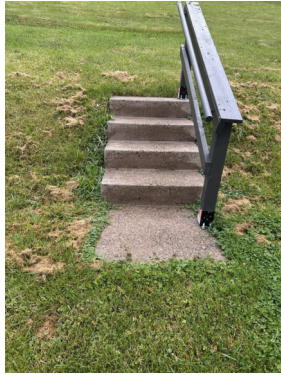
2.7.2 Loose Handrail

Loose handrail was observed during the inspection of the exterior steps. This creates a fall hazard. I recommend having it repaired or replaced.

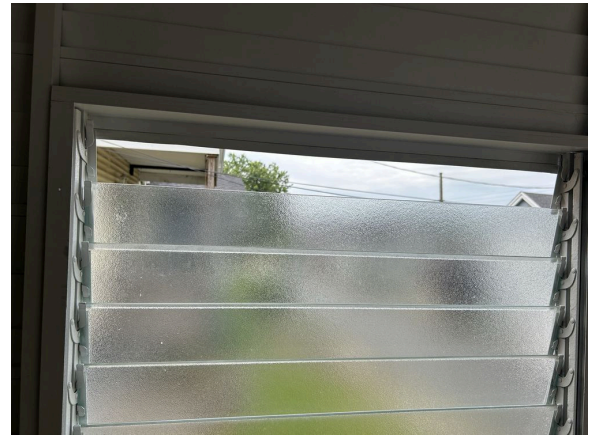
2.8.3 Material Defect

Front porch jalousie window is missing a glass slat/panel. I recommend repair or replacement to restore proper weather resistance and functionality.

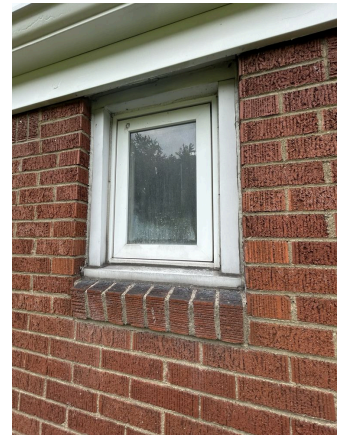
I observed a fogged windowpane (lost seal) during the exterior inspection.

Condensation or moisture trapped between windowpanes indicates seal failure. I recommend having it evaluated, repair or replaced by a window repair contractor.

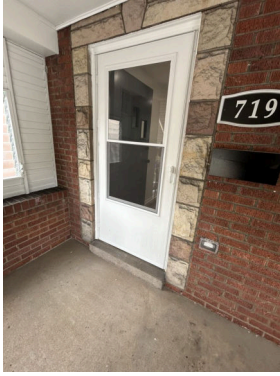
Front

The exterior doors were inspected.

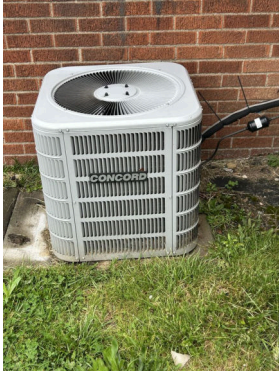
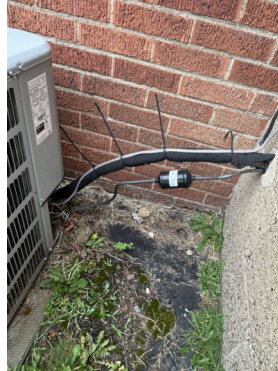
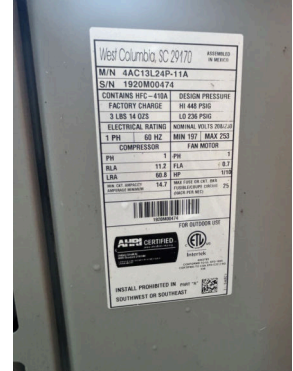
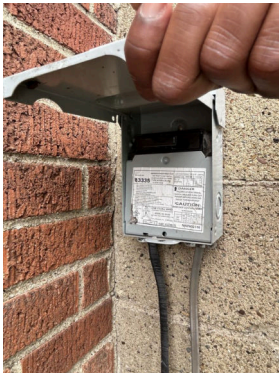
3.1.1 Brand: Concord

3.1.2 Energy Source/Type: Central Air Conditioner

3.1.3 Location: Exterior South

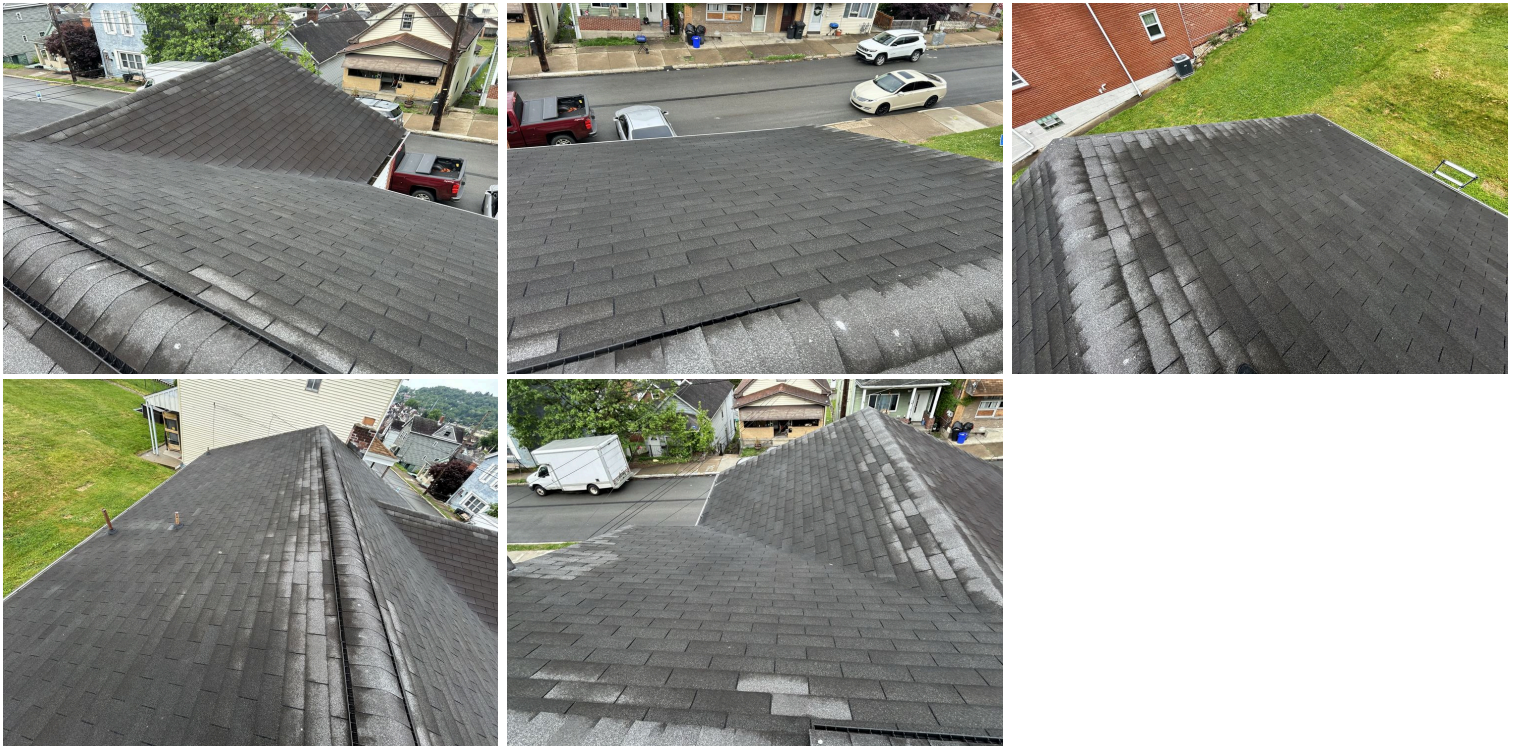
4.1.2 Inspection of Roof: Roof

I attempted to inspect the roof from various locations and methods, including from the ground and a ladder.

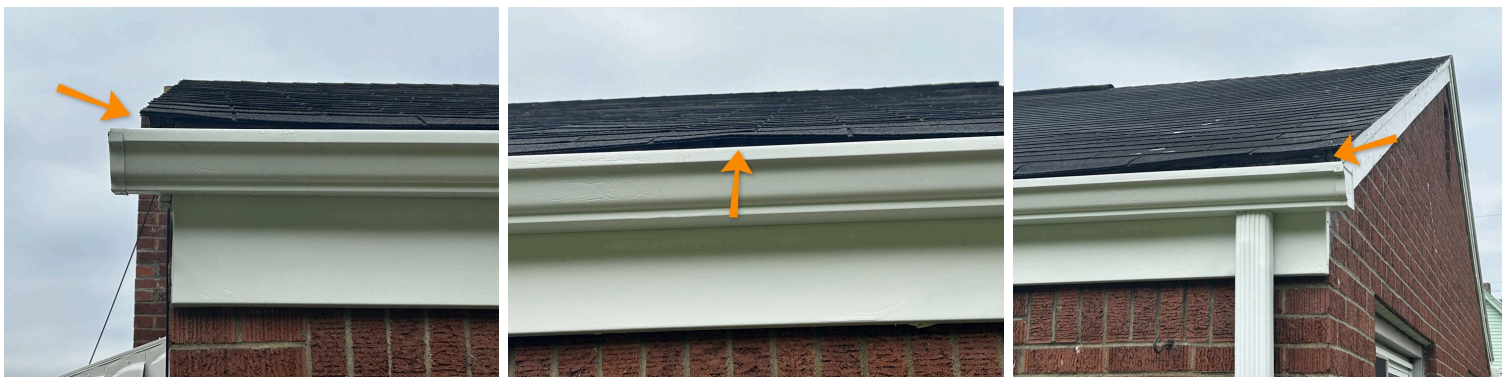
4.2.3 Missing Flashing

Flashings were missing at time of inspection.

Flashings provide protection against moisture intrusion.

Recommend a qualified roofing contractor evaluate and remedy.

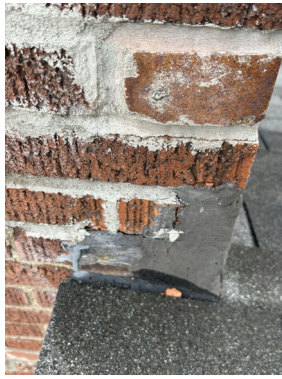
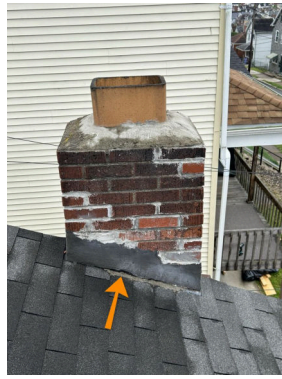
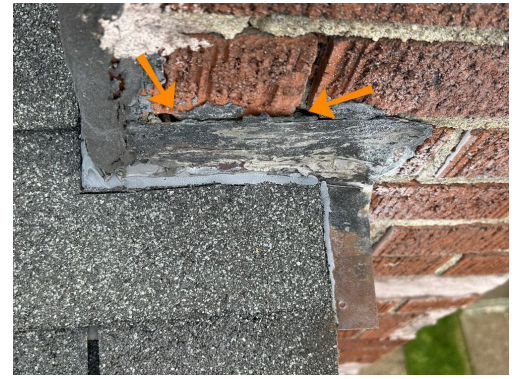
4.2.4 Deteriorated Chimney Flashing

Chimney flashing was observed to be deteriorated. Visible gaps, and signs of material deterioration were observed at the flashing components. I recommend evaluation and repair by a qualified roofing contractor.

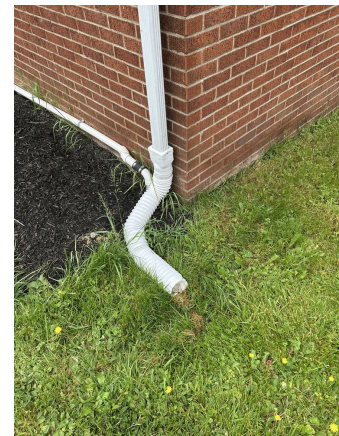
One or more downspouts drain too close to the home's foundation.

This can result in excessive moisture in the soil at the foundation, which can lead to foundation/structural movement.

Recommend a qualified contractor adjust downspout extensions to drain at least 6 feet from the foundation.

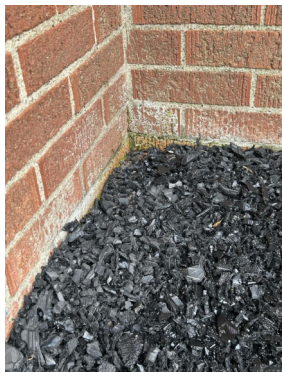
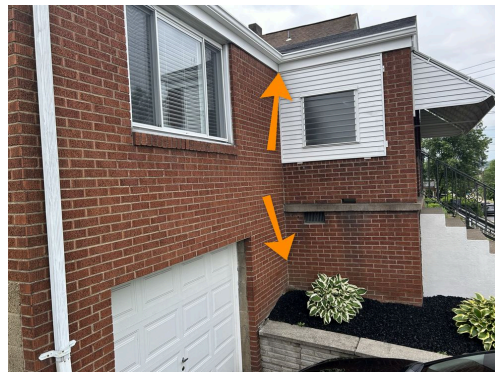
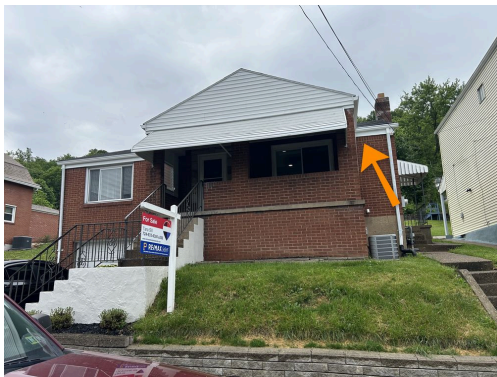
4.3.3 Gutter Leakage

Gutters were observed to be leaking in one or more areas.

This can result in excessive moisture in the soil at the foundation, which can lead to foundation/structural movement.

Left side of porch

Right side of porch

Recommend a qualified contractor evaluate and repair gutters to proper functionality.

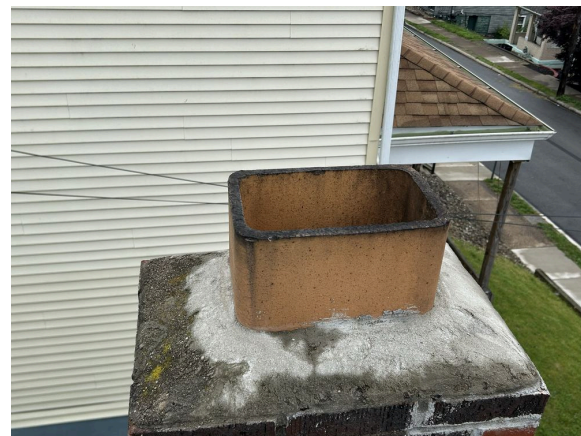
4.4.1 Chimney Cap Missing

No chimney cap was observed.

This is important to protect from moisture intrusion and protect the chimney.

Recommend a qualified roofer or chimney expert install.

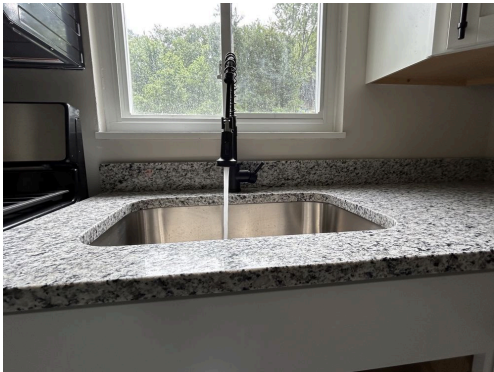
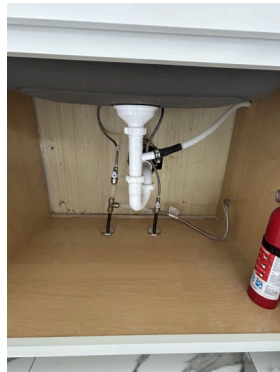
6.1.1 Ran Water at Kitchen Slnk

I ran the water at the kitchen sink during the inspection.

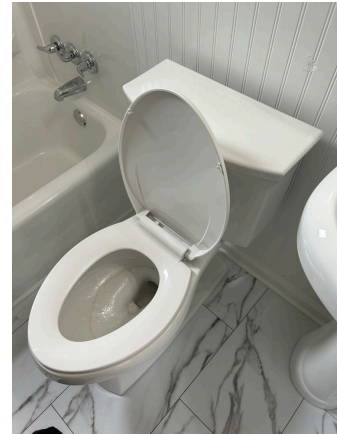
7.1.1 Toilets Inspected

Toilet fixture(s) were inspected to assess operational status and condition.

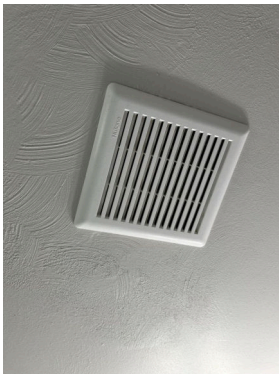
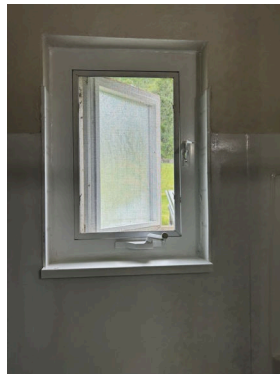
7.3.1 Exhaust Fan/Window Inspected

Bathroom exhaust fans and windows help remove moisture and odors from the bathroom environment. The fans are typically ducted to the exterior to prevent humidity build-up, which can lead to mold growth and structural damage if not properly vented.

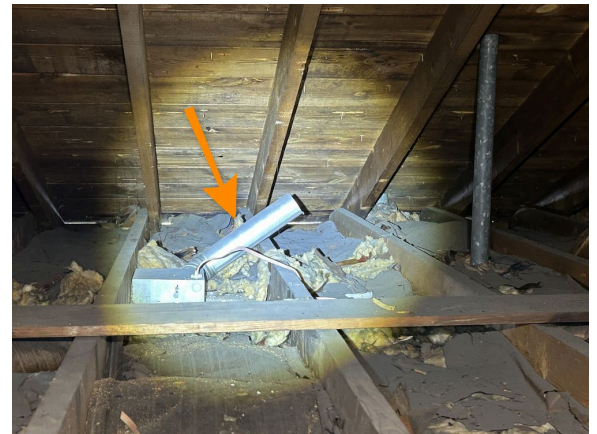
7.3.2 Exhaust Fan Not Properly Exhausting

The exhaust fan is not effectively removing moisture and odors from the bathroom. I recommend a qualified contractor inspect the ductwork for blockages, disconnections, or improper venting to ensure proper operation.

Bathroom exhaust vent

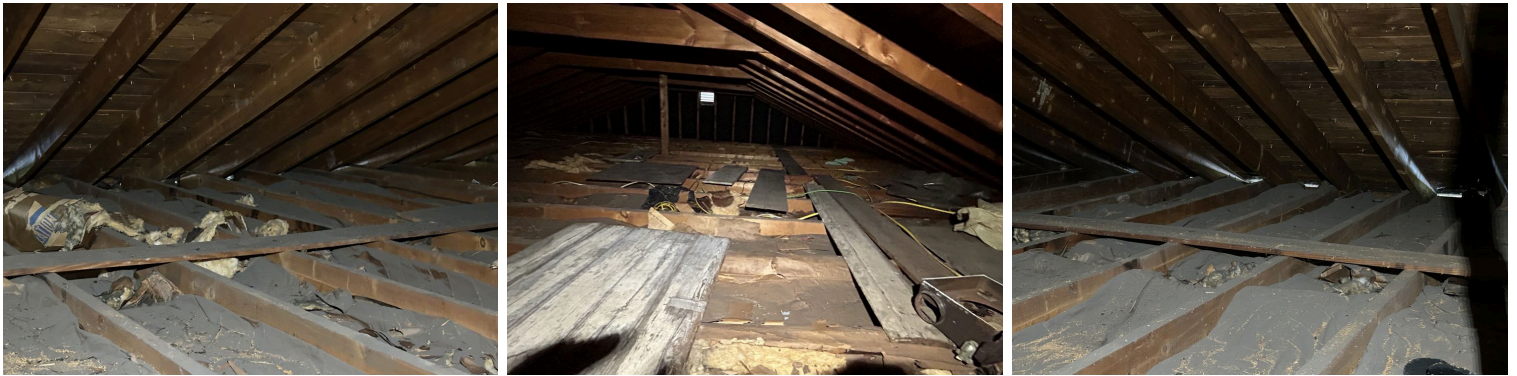
8.1.1 Insulation Type: Fiberglass

8.1.2 Attic Insulation Depth: 3-6"

Attic insulation depth refers to the thickness of insulation material installed between floor joist or rafters. Adequate insulation depth is essential for maintaining consistent indoor temperatures, reducing energy costs, and preventing heat loss during winter months. Typical recommendations vary by climate zone but generally range from R-30 to R-60 for attic space.

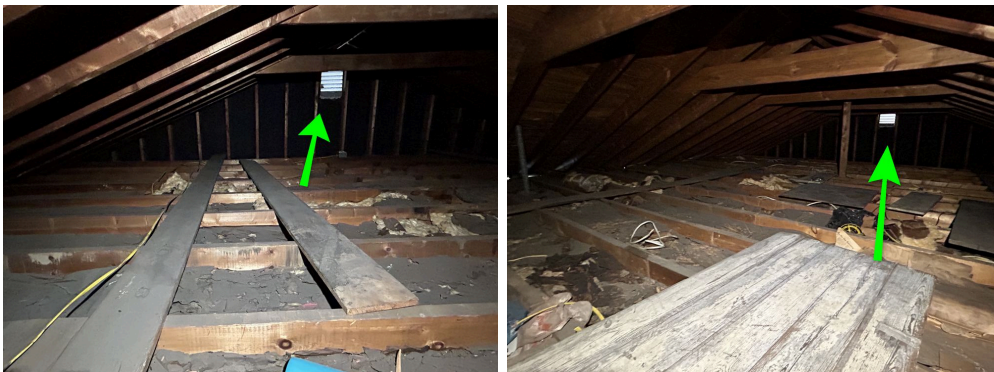
8.2.1 Attic Ventilation Type: Ridge Vents, Gable Vents

Attic ventilation refers to the system of air circulation designed to remove moisture and heat from the attic space. Proper ventilation helps prevent moisture build-up, reduces energy costs, and extends roof and insulation lifespan.

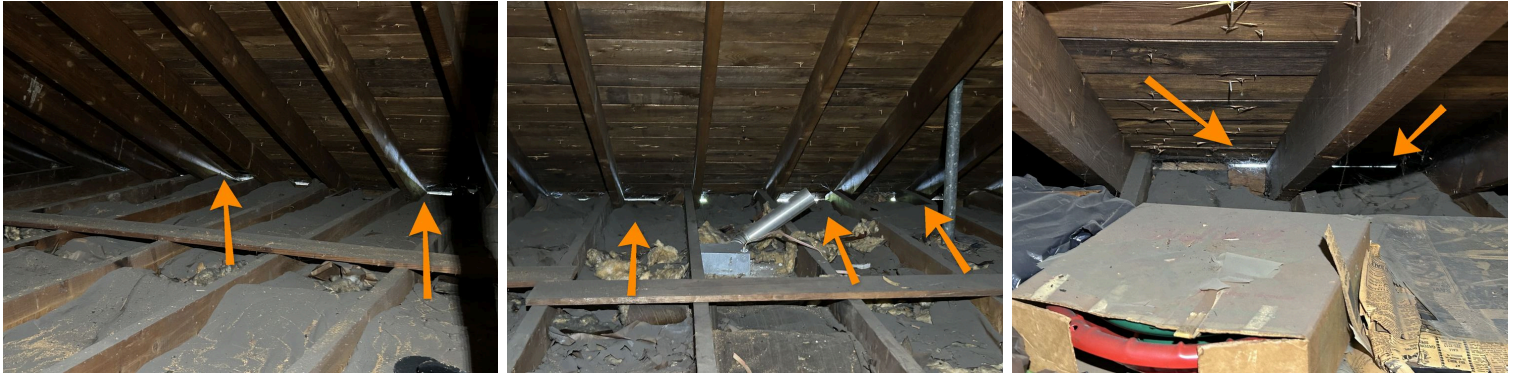
8.3.2 Defect In Attic

Opening at the eave areas were observed during the inspection. This defect may allow air movement, moisture intrusion, and/or pest entry. I recommend further evaluation and correction by a qualified contractor.

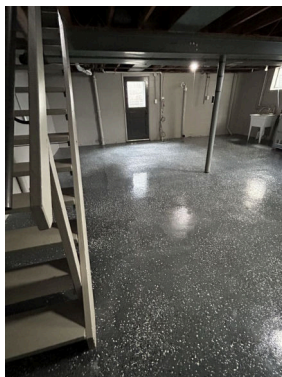
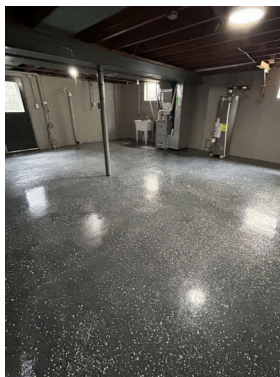
9.1.2 Basement Foundation Type: Concrete Block

The basement foundation is the structural system supporting the home's weight and transferring loads to the soil below. The foundation type affect the home's structural integrity, moisture resistance, and long term durability.

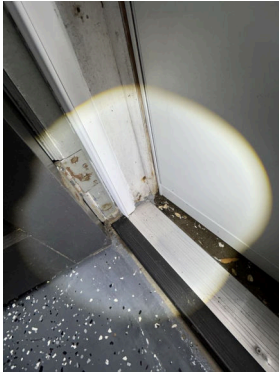
Evidence of past water intrusion was observed during the inspection. I recommend further evaluation by a qualified professional.

Basement doorway-bottom corner

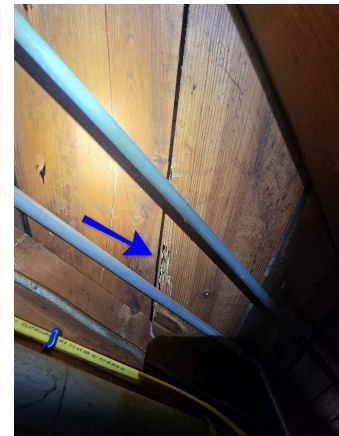
Evidence of wood destroying insect activity was observed at the time of the inspection. The visual damage appears localized, and not a significant structural concern. I recommend monitoring, and further evaluation by a qualified pest contractor.

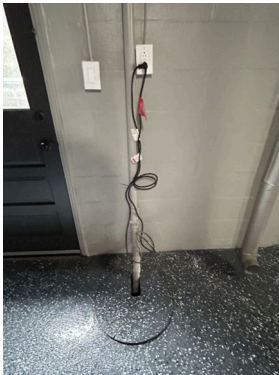
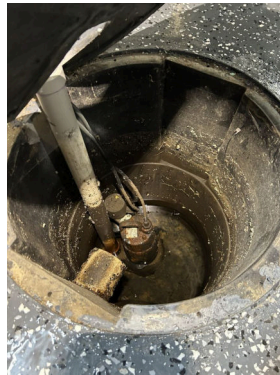
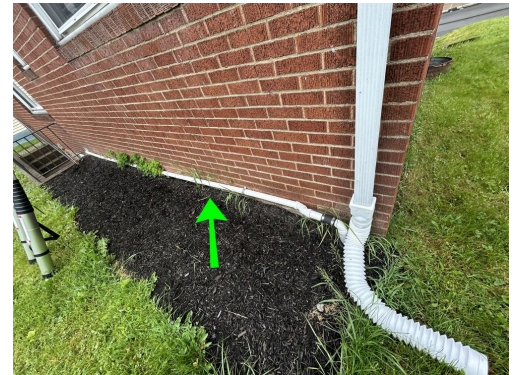
9.4.2 Water in Sump Pump

I observed standing water in the sump pump bucket. This may indicate that the sump pump is critical and necessary to keep the house basement or foundation from having water intrusion problems developing.

Sump Pump Discharge Pipe

A battery back up system for the sump pump is recommended to ensure continued operation during power outages.

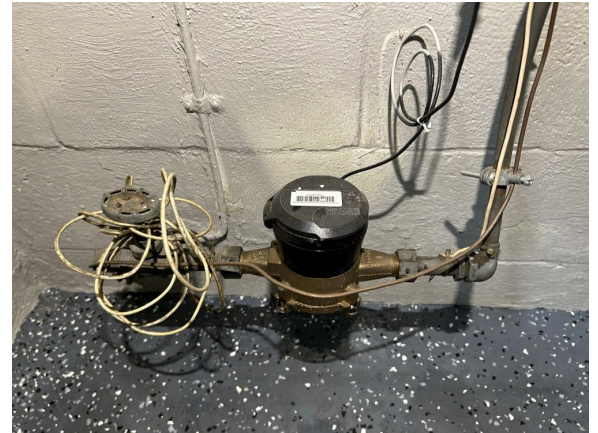
10.1.2 Main Water Shut Off Valve Location: Basement

The main water shut off valve controls the water supply to the entire house. Knowing its location is essential for emergencies, maintenance, and repairs. Homeowners should be simplify with accessing this valve quickly.

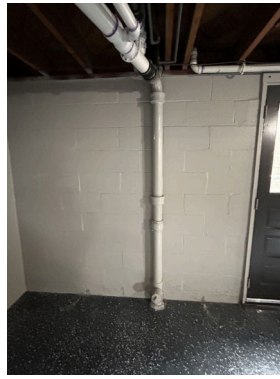
10.2.1 Drain,Waste, and Vent Systems Inspected

The drain, waste, and vent (DWV) system removes wastewater and gases from the home. It includes drain pipes that carry water away from the fixtures, waste pipes that handles sewage, and vent pipes that allow gases to escape and maintain proper pressure. These systems are essential for sanitation and proper fixture operation.

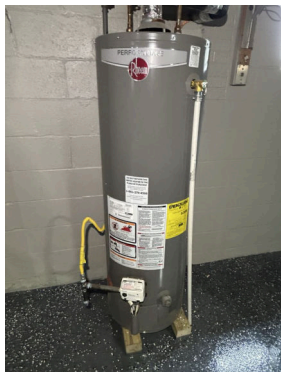
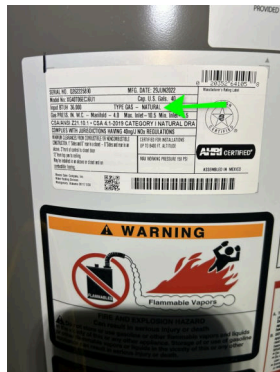
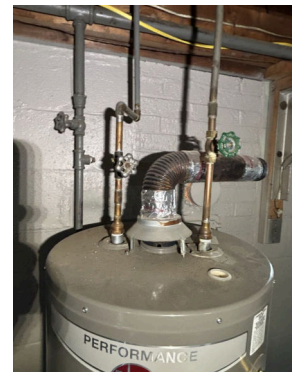
10.4.1 Hot Water Source Type: Gas Water Heater

The hot water source is the system that heats the water for domestic use throughout the home.

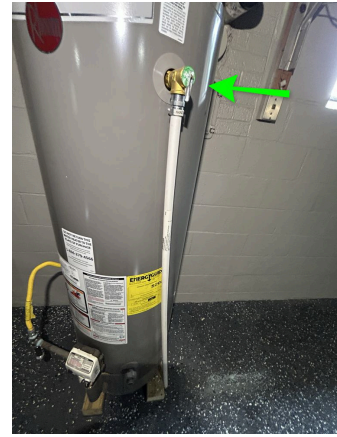
10.4.2 Temperature Pressure Relief Valve

The TPR valve on the water heater was inspected. This safety device automatically releases pressure and temperature to prevent tank rupture and is a critical component of the hot water system.

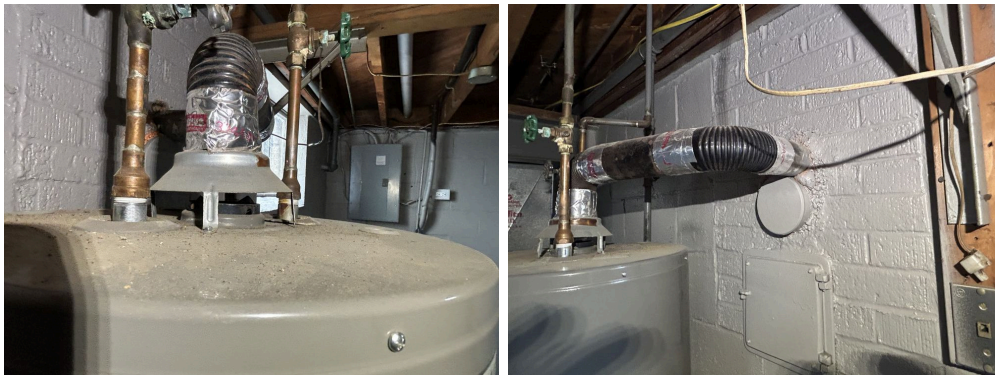
10.4.3 Hot Water Venting Connections

The hot water venting connections were inspected. Proper venting is essential for safe operation and efficient performance of the water heating systems.

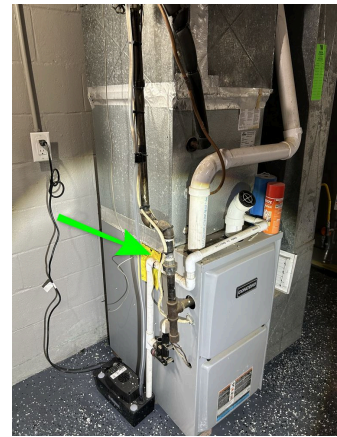
11.1.2 Heating System Energy Source: Natural Gas

Gas line

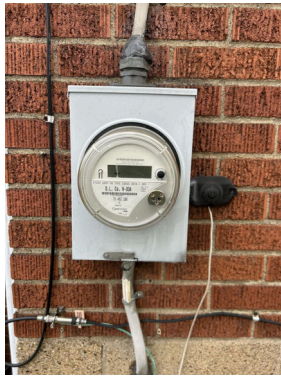
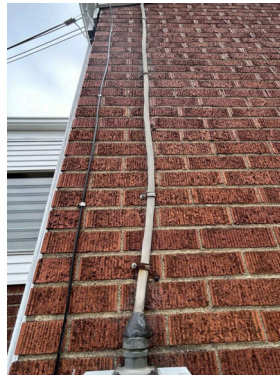
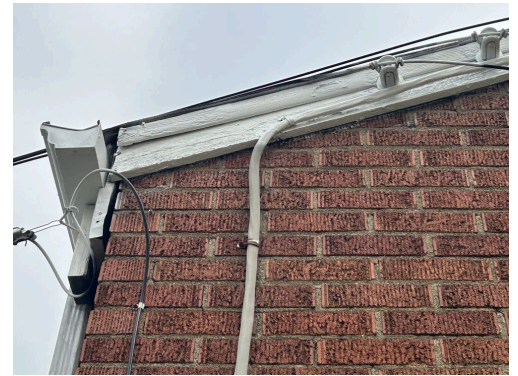
12.1.1 Electrical Meter & Base Inspected

The electrical meter and base were inspected. This component serves as the point where the utility power enters the home and measures electrical consumption for billing purposes.

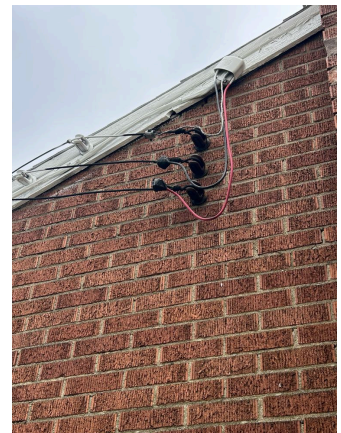
12.2.1 Service Entrance Conductors Inspected

Service entrance conductors are the main electrical cables that carry power from the utility meter or service panel into the homes electrical system. These conductors must be properly sized, protected, and installed to safely deliver electricity throughout the property.

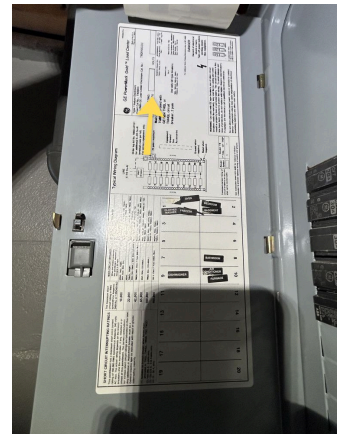
12.3.4 Main Service Disconnect Rating Not Labeled

The amperage rating of the main service disconnect is not clearly labeled or visible. This information is essential for understanding the electrical service capacity and for troubleshooting electrical issues.

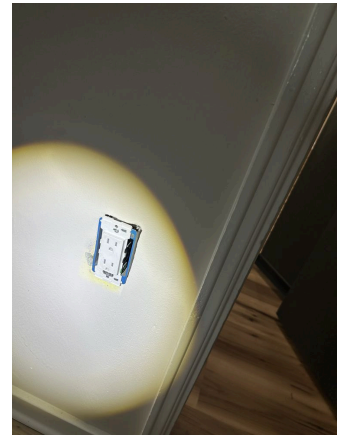
12.4.1 Cover Plates Missing

Cover plates were missing at one or more electrical switches, and/or receptacles. This condition may expose energized components and presents a potential shock hazard.

Living room closet

I recommend installation of proper cover plates.

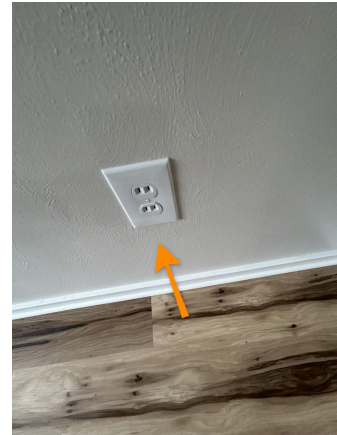
12.4.2 Ungrounded Receptacles

Ungrounded electrical receptacles were observed at one or more locations. This condition indicates the absence of an effective equipment grounding path and may increase the risk of electrical shock. Evaluation and correction by a qualified electrician is recommended.

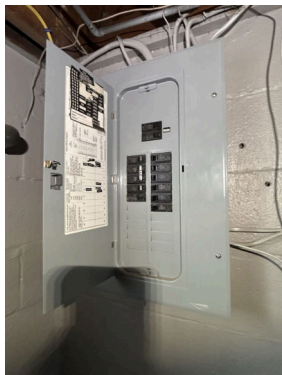
12.6.1 Main Panel Board & Breakers

The main electrical panel board and circuit breakers were inspected. The panel board is the central distribution point for electrical power throughout the home, containing circuit breakers that protect individual circuits from overload.

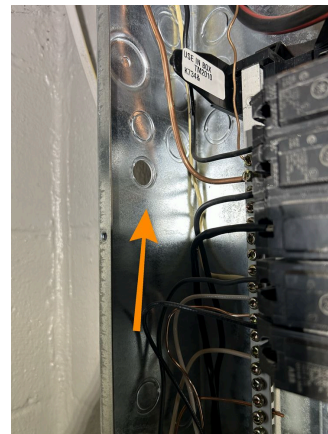
12.6.2 Open Breaker Knockout (Filler Plate Missing)

An open breaker knockout was observed in the electrical panel at the time of the inspection due to a missing filler plate. This condition may expose energized components and reduce panel safety. Installation of an appropriate cover plate is recommended.

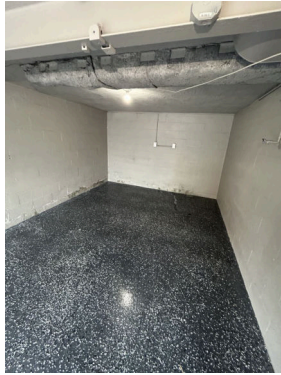
13.1.1 Garage Floor Inspected

The garage floor was examined during the inspection. Garage floors are typically constructed of concrete and may show various conditions including cracks, staining, or surface wear depending on age and maintenance history.

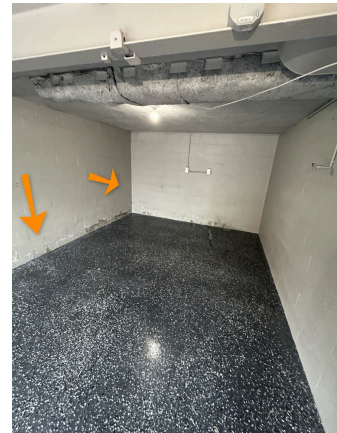
13.1.2 Efflorescence

White, chalky mineral deposits observed on the garage floor surface. This indicates moisture has been moving through the concrete, carrying dissolved salts to the surface where they crystallize. I recommend an evaluation by a qualified professional.

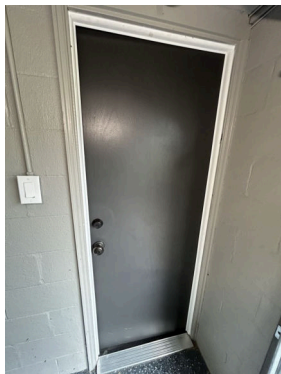
13.2.2 Door Between Garage & House Inspected

The door connecting the garage to the interior of the house was inspected.
